Inspection Report

Minerals Regulatory Program

Mine Name: Walker Flat	Permit Number: S/015/0081
Operator Name: Miracle Rock Mining and Research	Inspection Date: July 26, 2012
Inspector(s): Paul Baker and Lynn Kunzler	Time: About 12:00-12:30 PM
Other Participants: None	Mine Status: Reclaimed

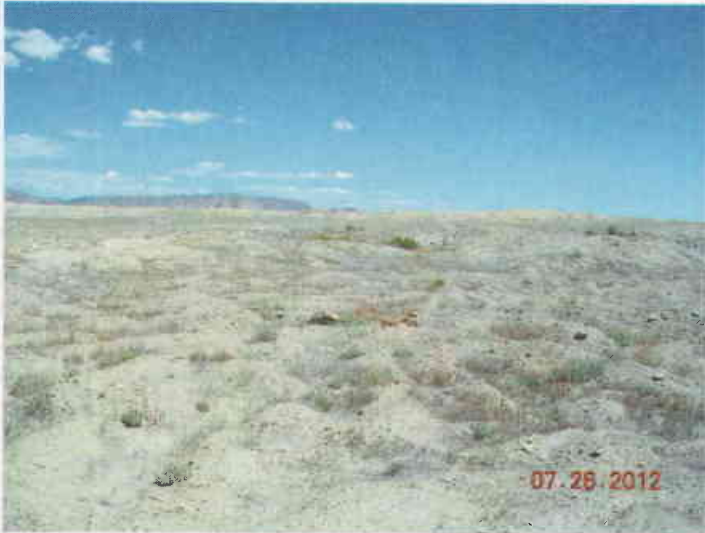
Photo 1. An overview of the area near the entrance

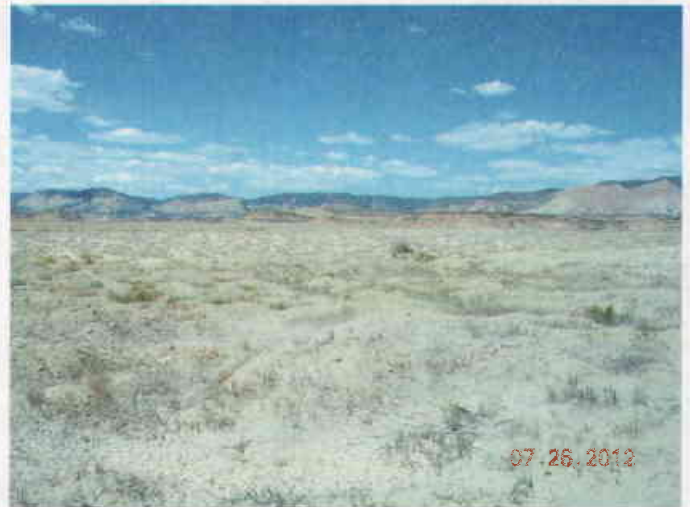
Photo 3. The flat area beyond the disturbed area shows the type of vegetation in undisturbed areas.

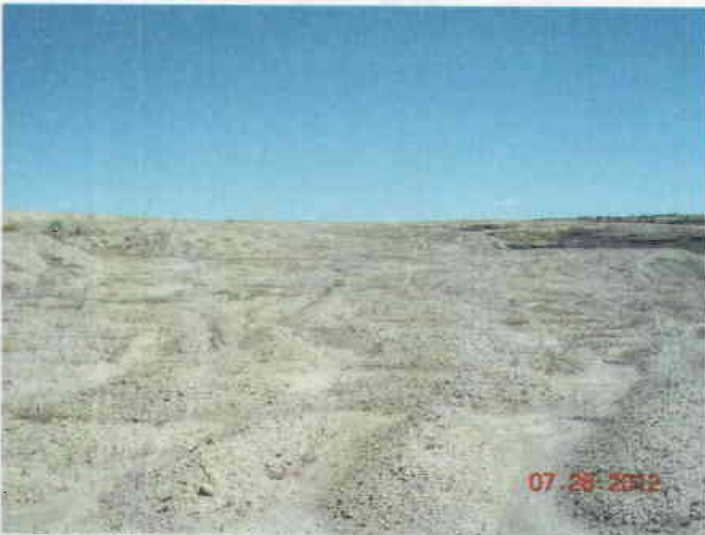
We did not measure vegetation cover, but it is not 70 percent of the cover in adjacent undisturbed areas.

Photo 2. This area has almost no vegetation.

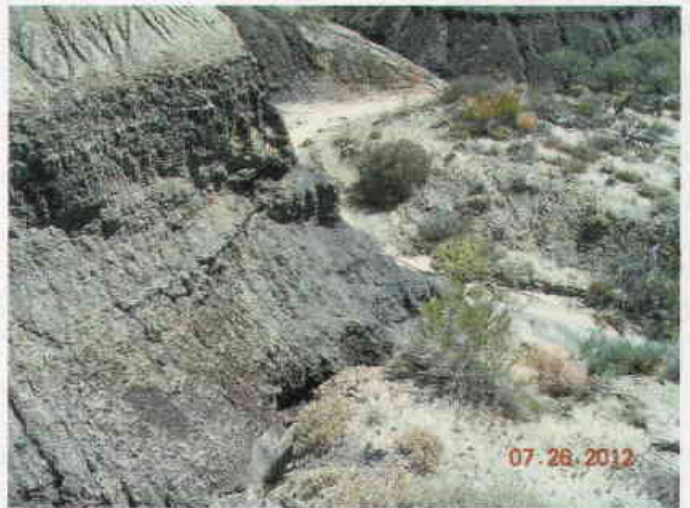
There are places where there is a steep drop from the mined area to the adjacent drainage, and some of these places have had fairly substantial erosion. Adjacent undisturbed areas have a similar problem though possibly not quite as bad.

There is some increased erosion coming from the disturbed areas, but this is showing signs of stabilizing. The entire area around the mine is erosive.

Photo 4. There has been some erosion coming off the reclaimed area into an adjacent channel, but the entire area is erosive.
